**Flood Control Project Maintenance
Levee Inspections****LMA District Cover Sheet****Spring 2012 Levee Inspection Results****Levee District No. 0001 (Sutter County)**

Spring 2012 Levee Inspection Results

Levee District No. 0001 (Sutter County)

| Waterway | | | Bank | Unit Miles |
|--|---|---|---|---|
| Unit No. 01 Feather River | | | Right | 16.65 |

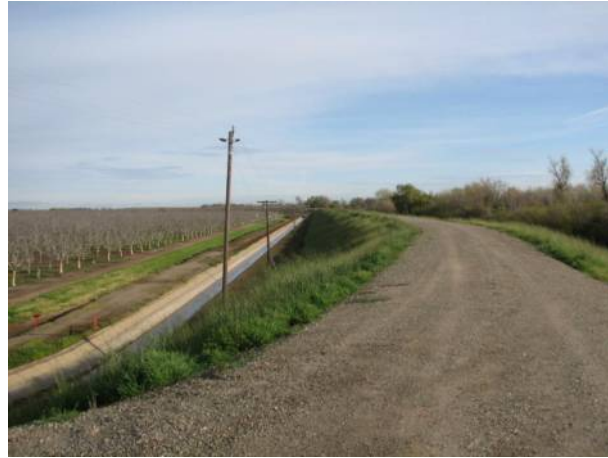
cathom_s_20120329_413.JPG

| LMR No. | Levee Mile | | Category | Item | Location | Rating | Action/Comment | GPS Latitude/Longitude | | Issue No. |
|---|---|---|---|---|---|---|--|---|---|---|
| 4 | 0.00 | 8.36 | Earthen Levee | Vegetation | LS | M Ma | V1 : Control annual grass and weeds on the levee slopes and easements. | 38.951042 ° -121.585735 ° | 39.062978 ° -121.610848 ° | 5 Y |

This photo was taken at levee mile 0.00 looking upstream at the landside vegetation.

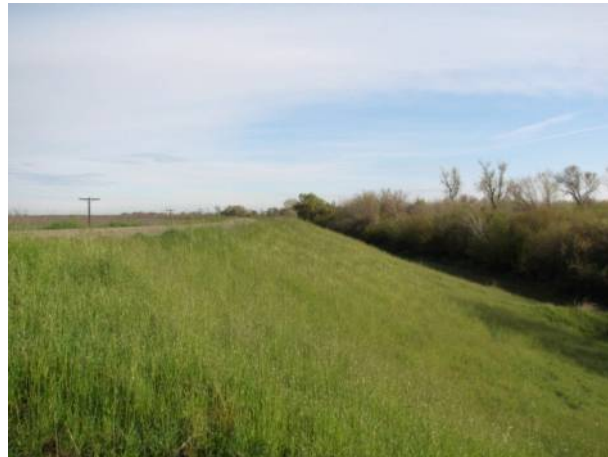
cathom_s_20120329_414.JPG

| LMR No. | Levee Mile | | Category | Item | Location | Rating | Action/Comment | GPS Latitude/Longitude | | Issue No. |
|---|---|---|---|---|---|---|--|---|---|---|
| 5 | 0.00 | 8.36 | Earthen Levee | Vegetation | WS | M Ma | V1 : Control annual grass and weeds on the levee slopes and easements. | 38.951041 ° -121.585735 ° | 39.062979 ° -121.610848 ° | 491 Y |

This photo was taken at levee mile 0.00 looking upstream at the waterside vegetation.

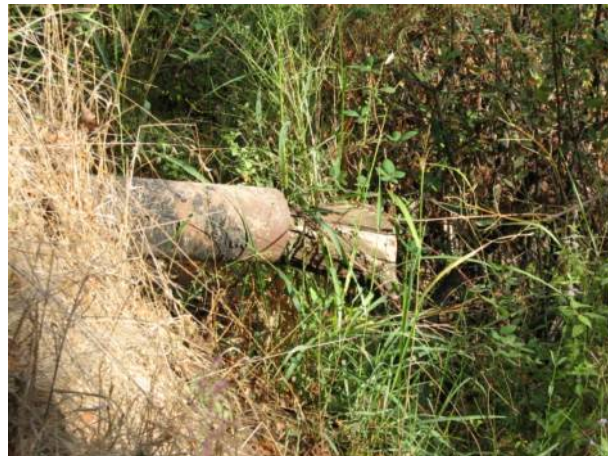
cathom_s_20120307_001.jpg

| LMR No. | Levee Mile | | Category | Item | Location | Rating | Action/Comment | GPS Latitude/Longitude | | Issue No. |
|---|---|---|---|---|---|---|--|---|---|---|
| 8 | 1.84 | 1.84 | Interior Drainage & Piping Systems | Metal Pipes | LS | M Ma | Inspector Comments: abandoned pipe. This pipe is listed in our levee log as an abandoned pipe, no date listed. No permit number. | 38.976927 ° -121.591210 ° | 38.976927 ° -121.591210 ° | 487 Y |

This photo shows the abandoned pipe on the waterside berm, note the piece of wood stuck in the pipe.
